**CANADIAN FORCES
FLIGHT SAFETY INVESTIGATION REPORT (FSIR)**

FINAL REPORT

FILE NUMBER: 1010-CH146434 (DFS 2-4)
FSOMS: 139123
DATE OF REPORT: 29 October 2012
AIRCRAFT TYPE: CH146 Griffon Helicopter
DATE/TIME: 06 0908Z July 2009
LOCATION: Forward Operating Base, Afghanistan
CATEGORY: "A" Category Accident

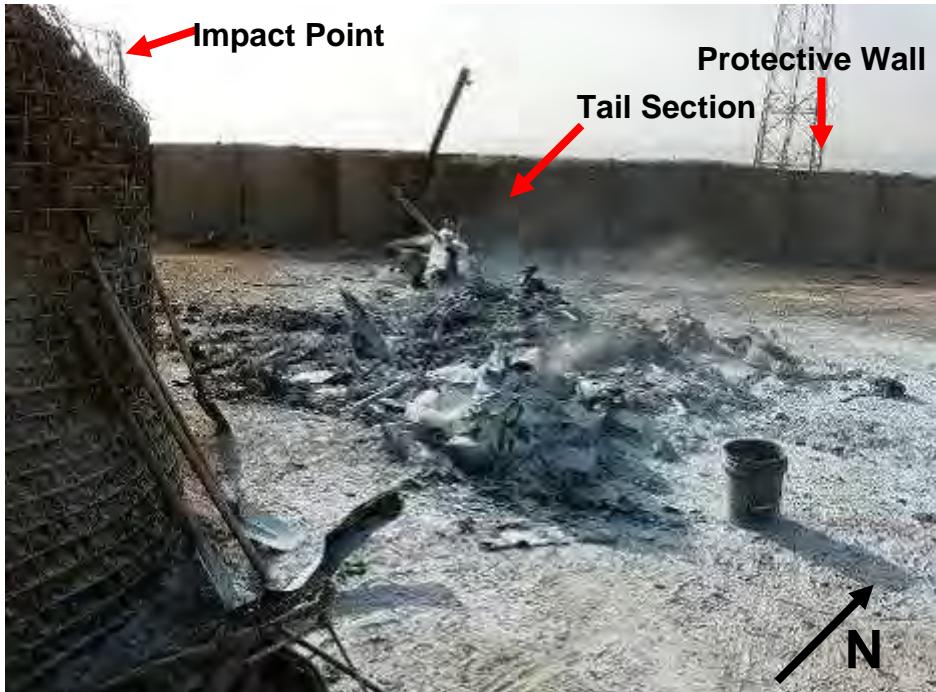
Photo 1: Accident site from impact point

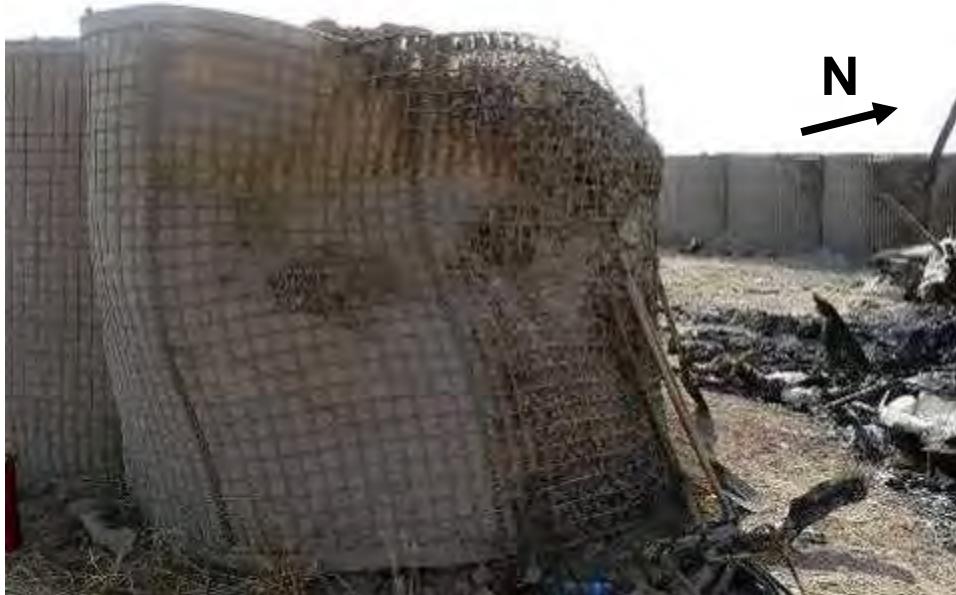
1.4.2 The aircraft fuselage struck and damaged the barrier's metal wire mesh structure ([Annex A: Photo 2](#)). All other damage to the barrier's retaining membrane (inner fabric) was caused by either fire or contact with flying aircraft debris. There were two main rotor blade strike marks at approximately a 45° angle on the right side of the impact point on the barrier ([Annex A: Photo 3](#)).

Photo 2: Damaged barrier showing side of aircraft impact

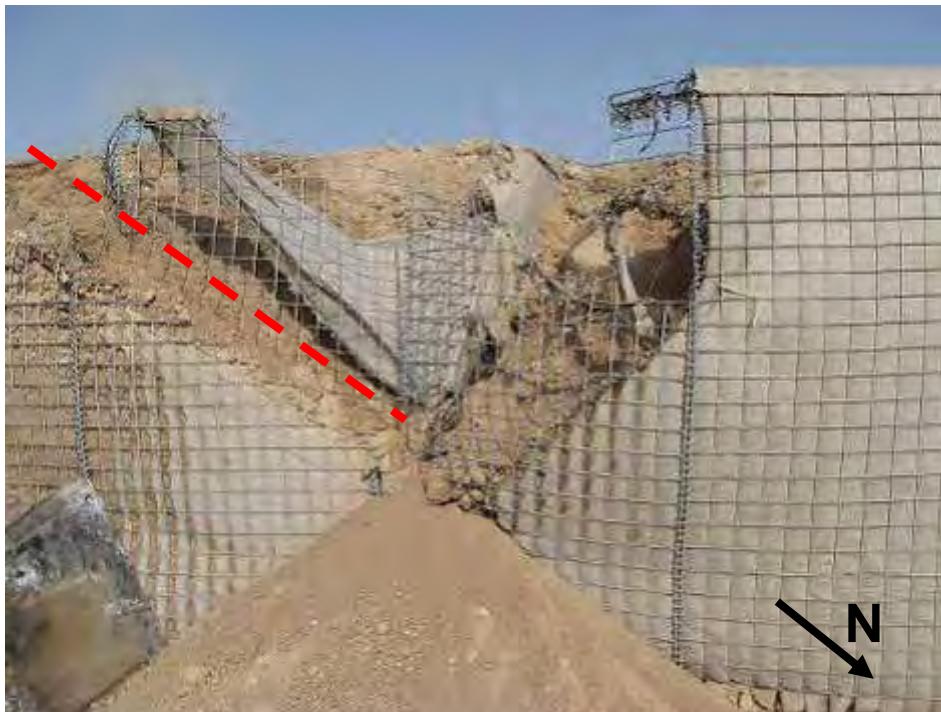
Photo 3: Damaged barrier showing main rotor blade strike

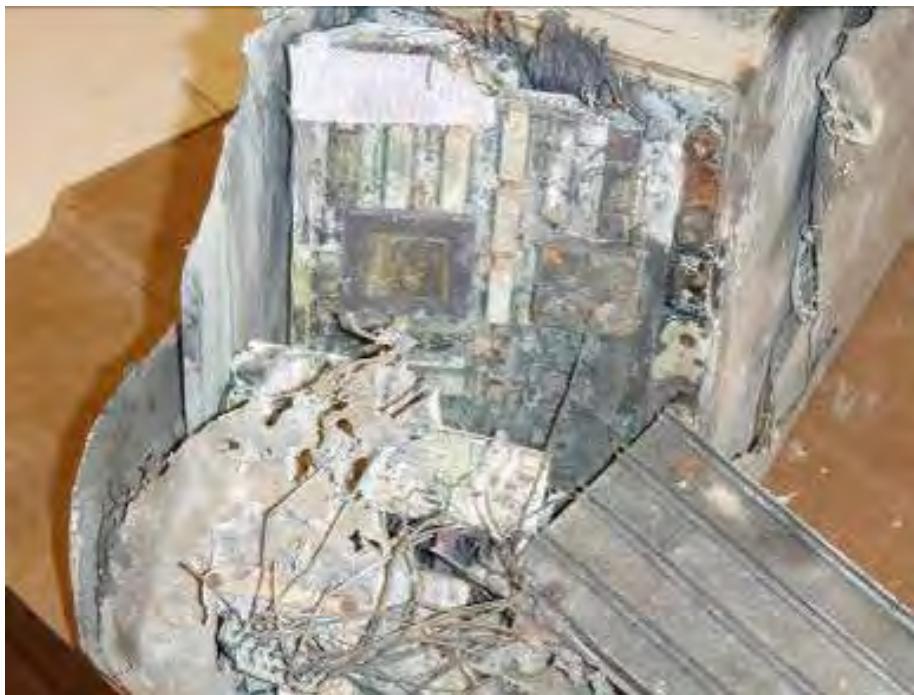
1.11.1.2 Preliminary inspection of the CVFDR revealed a breach of the unit's integrity and severe localized heat damage. The recorder was sent to the National Research Council (NRC) Flight Data Recorder Replay Center in Ottawa where it was confirmed that the unit sustained fire and heat damage ([Annex A: Photo 4](#)) that significantly exceeded its design limits. However, NRC, in conjunction with the CVFDR manufacturer, was able to recover the majority of the stored data by placing the accident CVFDR memory chips into a serviceable CVFDR.

Photo 4: CVFDR as received at NRC

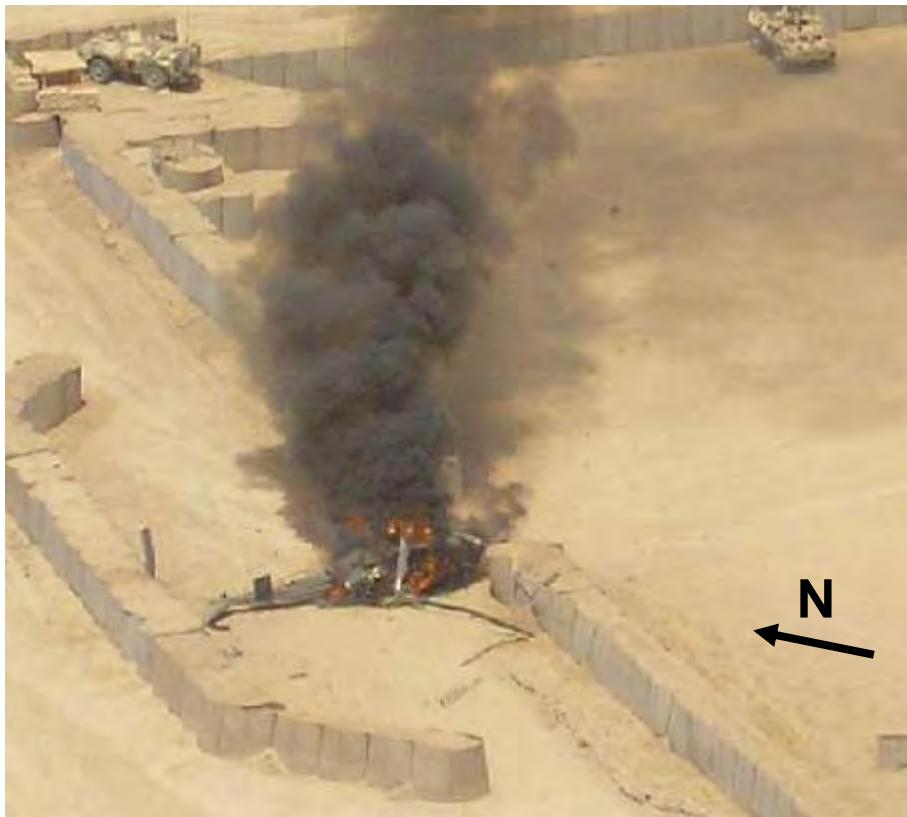
1.12.1 The barrier where the aircraft impacted was located approximately 95 ft away from the takeoff point and located at the one to two o'clock position relative to the nose of the aircraft. The impact point was approximately four to five ft high on the inside wall of the barrier ([Annex A: Photo 2](#)). Two distinct main rotor blade strikes were found on the outside wall of the barrier, cutting at approximately a 45° angle from the horizontal ([Annex A: Photo 3](#)). One of the main rotor blades was severed just inside the blade attachment point and lodged itself into the barrier opposite the FOB entrance. One of the oil cooler inlet cowlings was thrown over the barrier opposite the FOB entrance when it was struck by a main rotor blade. The right pilot windscreens shattered on impact with either the barrier or the ground. Otherwise, the aircraft was relatively intact when it came to rest on its right side ([Annex A: Photo 5](#)).

Photo 5: Accident site after the evacuation of survivors

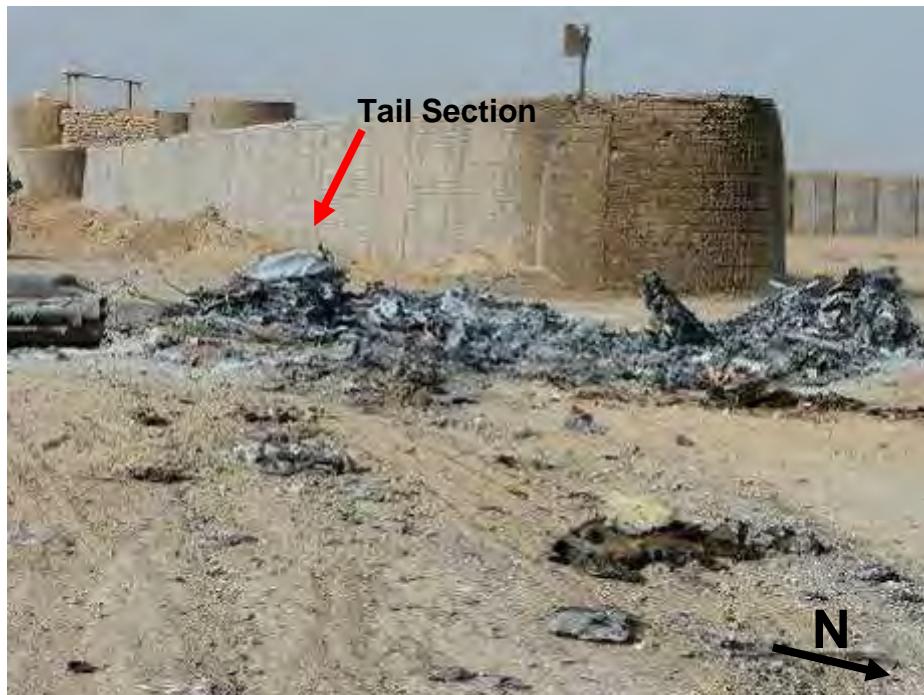
1.14.1.1 The aircraft caught fire immediately after coming to rest on its side. The FDR data indicated that the number Two Engine Fire Warning light illuminated, followed immediately by the number One Engine Fire Warning light. The pilots recalled seeing the illumination of these lights and having pulled the FIRE PULL handles. The fire was first observed in the rear cabin in the vicinity of the number two hydraulic pump near the ceiling of the cabin in front of the transmission housing. Both hydraulic and fuel lines are routed through the transmission housing. Hydraulic fluid (MIL-PRF-5606 type) is extremely flammable, as is aviation turbine fuel (JP-8 or F-34 type). Aviation turbine fuel vapours are heavier than air and may travel a considerable distance to sources of ignition and then flash back. The precise cause of the fire or the source of ignition could not be determined. The fire intensity was such that it prevented the pilots from assisting personnel in the rear cabin area and melted or reduced to ash nearly all parts of the aircraft forward of the tail section ([Annex A: Photo 6](#)).

Photo 6: Accident site looking from the protective wall

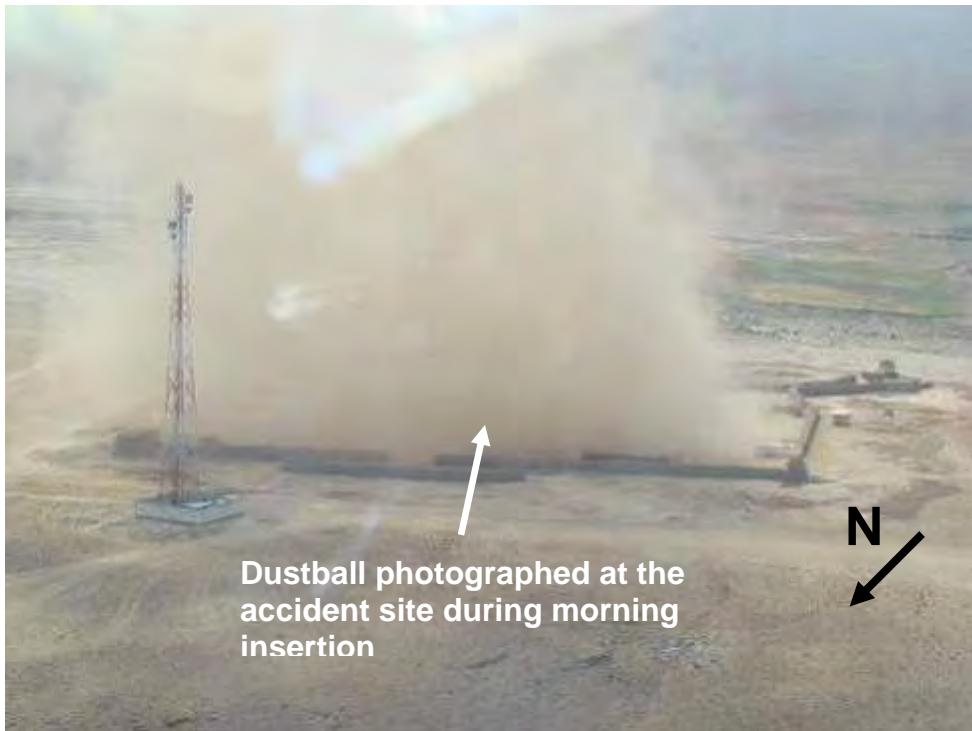
Photo 7: A dustball at the accident site as viewed from the air

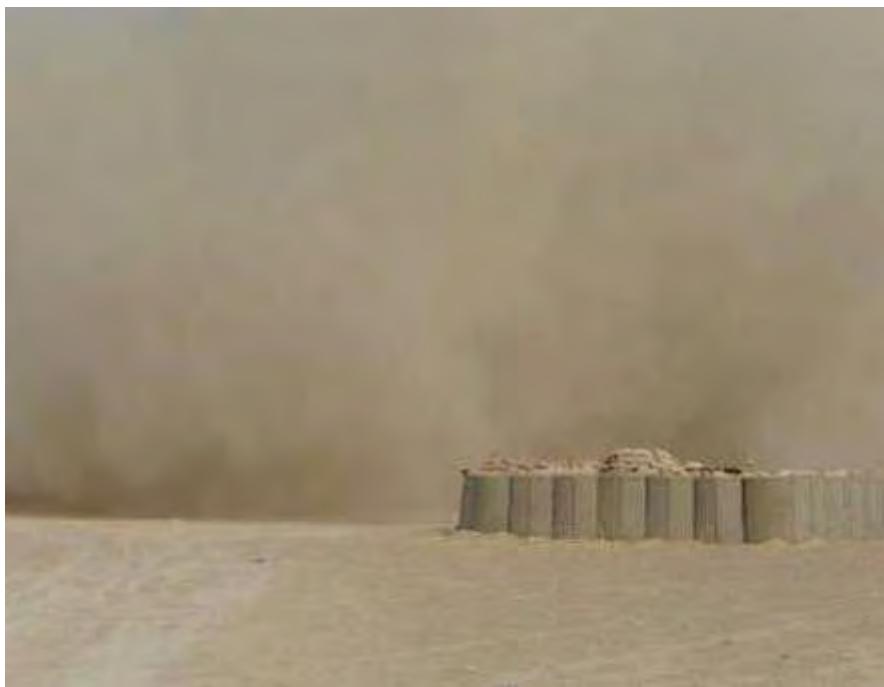
Photo 8: A dustball at the accident site as viewed from the ground

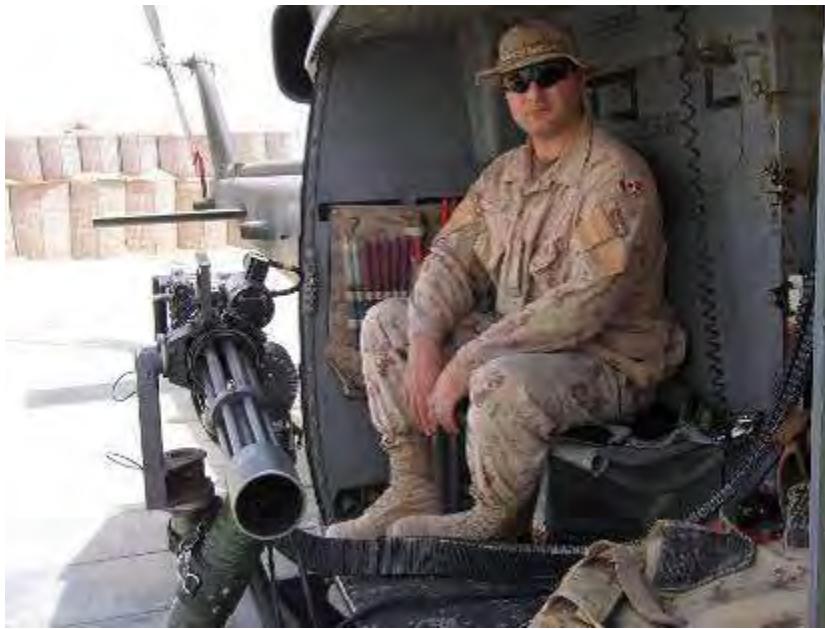
Photo 9: Transmission side-facing seat, FE side (investigator seated, photo used with permission)

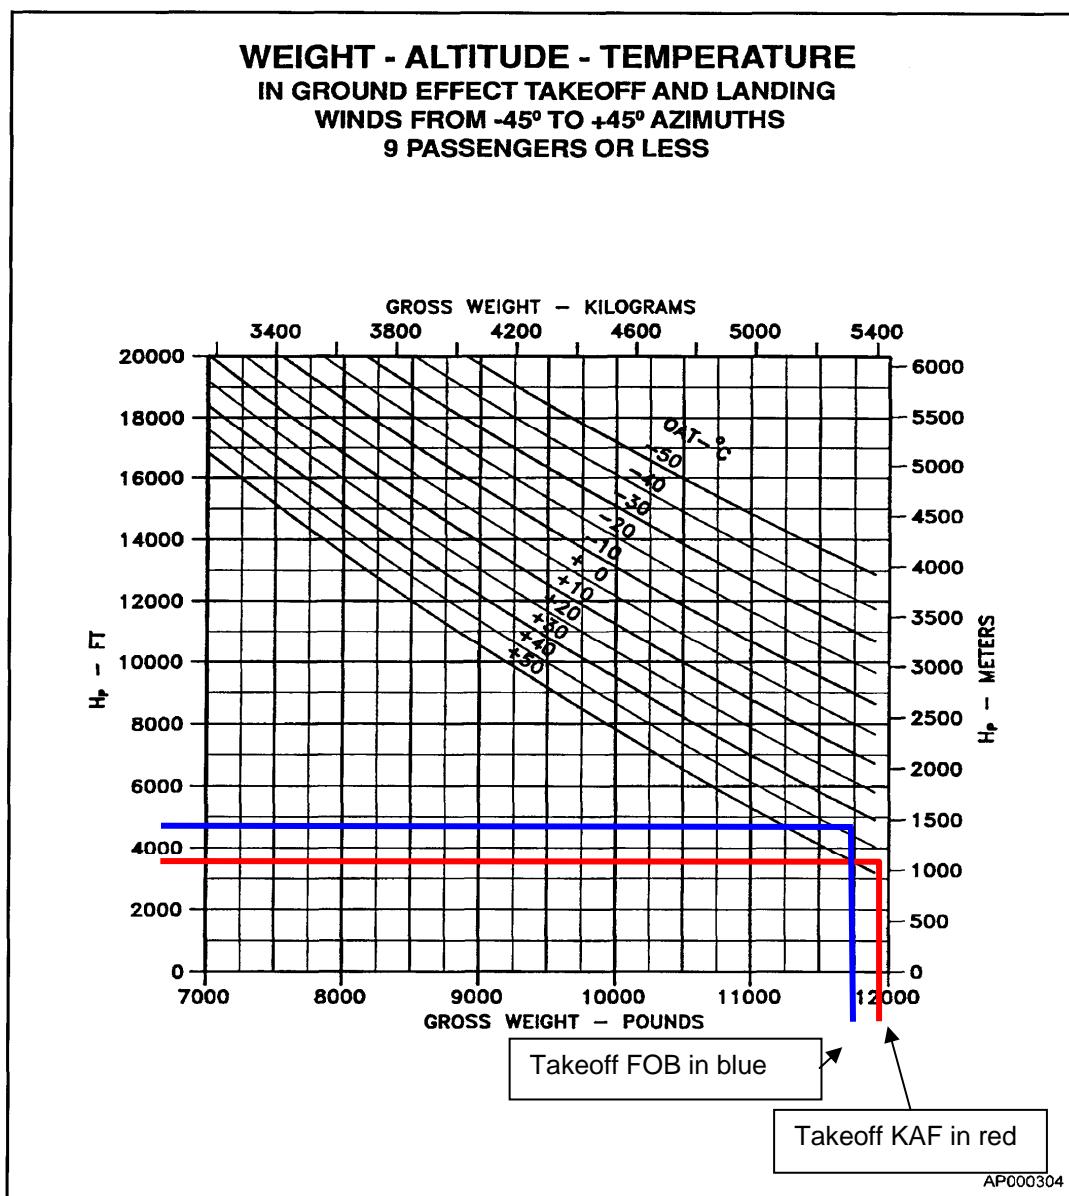
Figure 1-1A: WAT Chart – IGE

Note: KAF takeoff in red, FOB takeoff FOB in blue. Notice the lack of a note to refer to Hover Ceiling charts and lack of a Limit Line to guarantee Min Spec performance. This chart has since been removed.

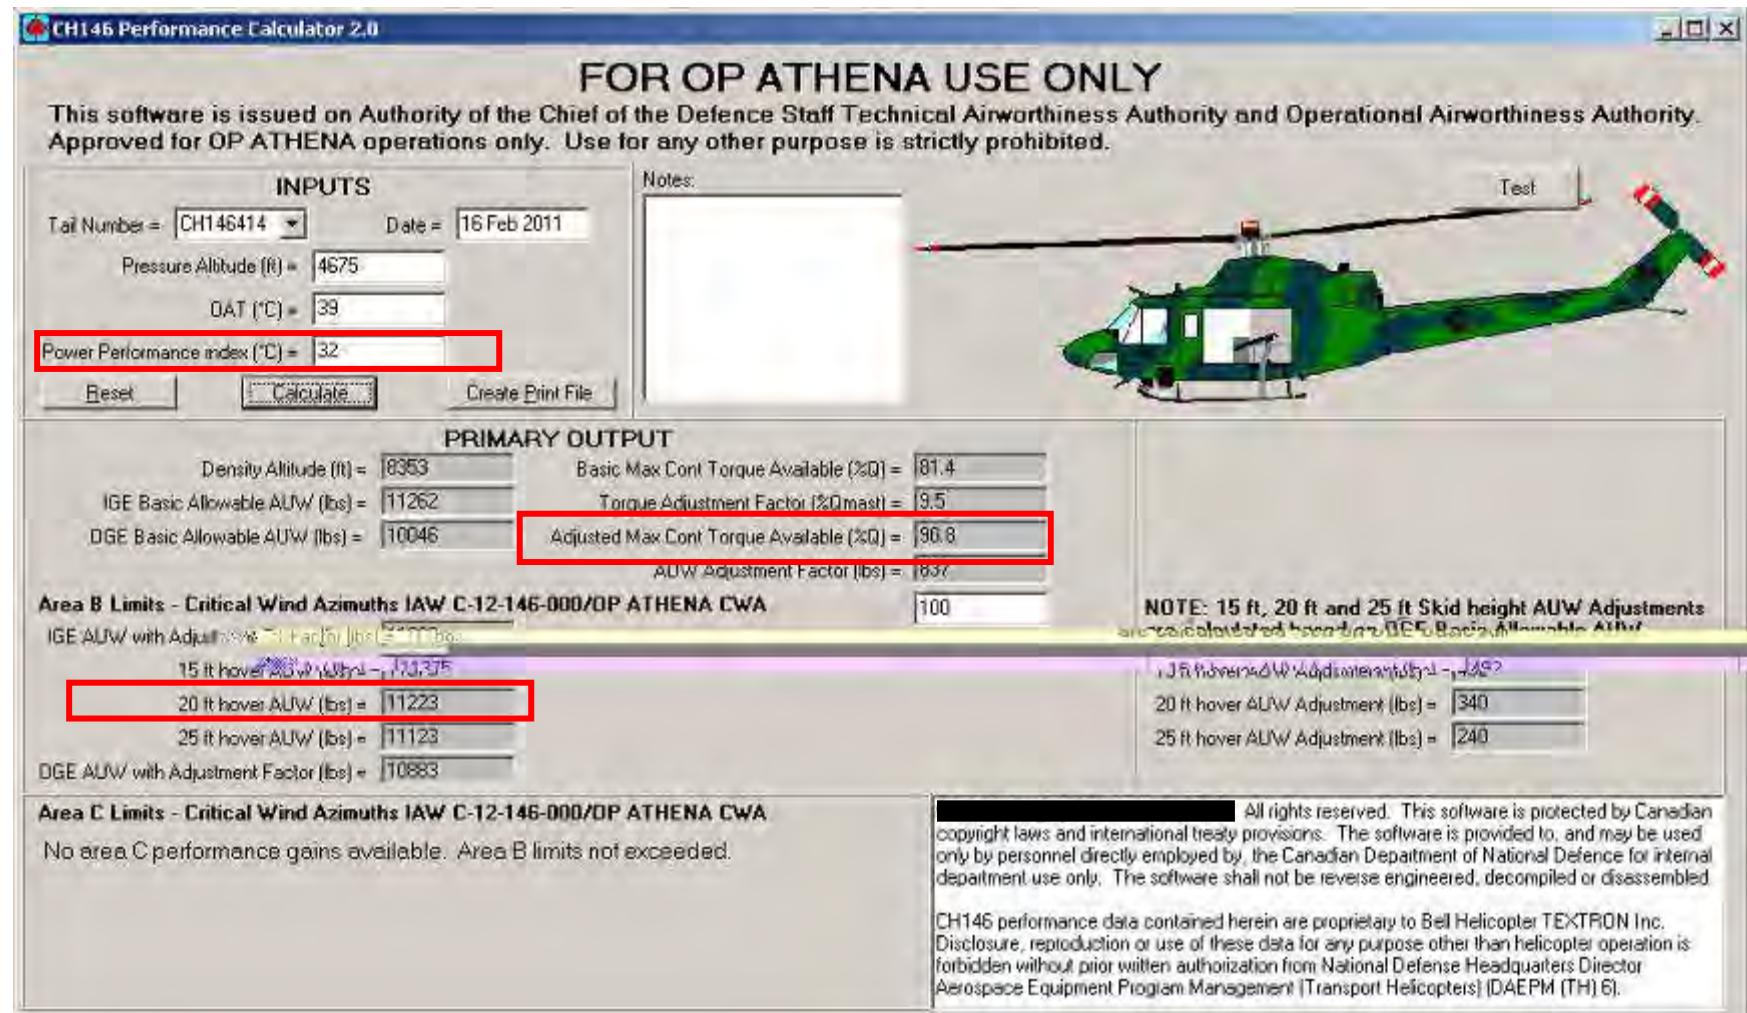
Figure 3 - The #2 aircraft at a 20' hover. Note 90.8 % Qm and 32°C PPI. Since baseline PPI was 25.4°C this indicates that they would have seen and ITT exceedences of 6.6°C to hover at 20'. (32 – 25.4 = 6.6)

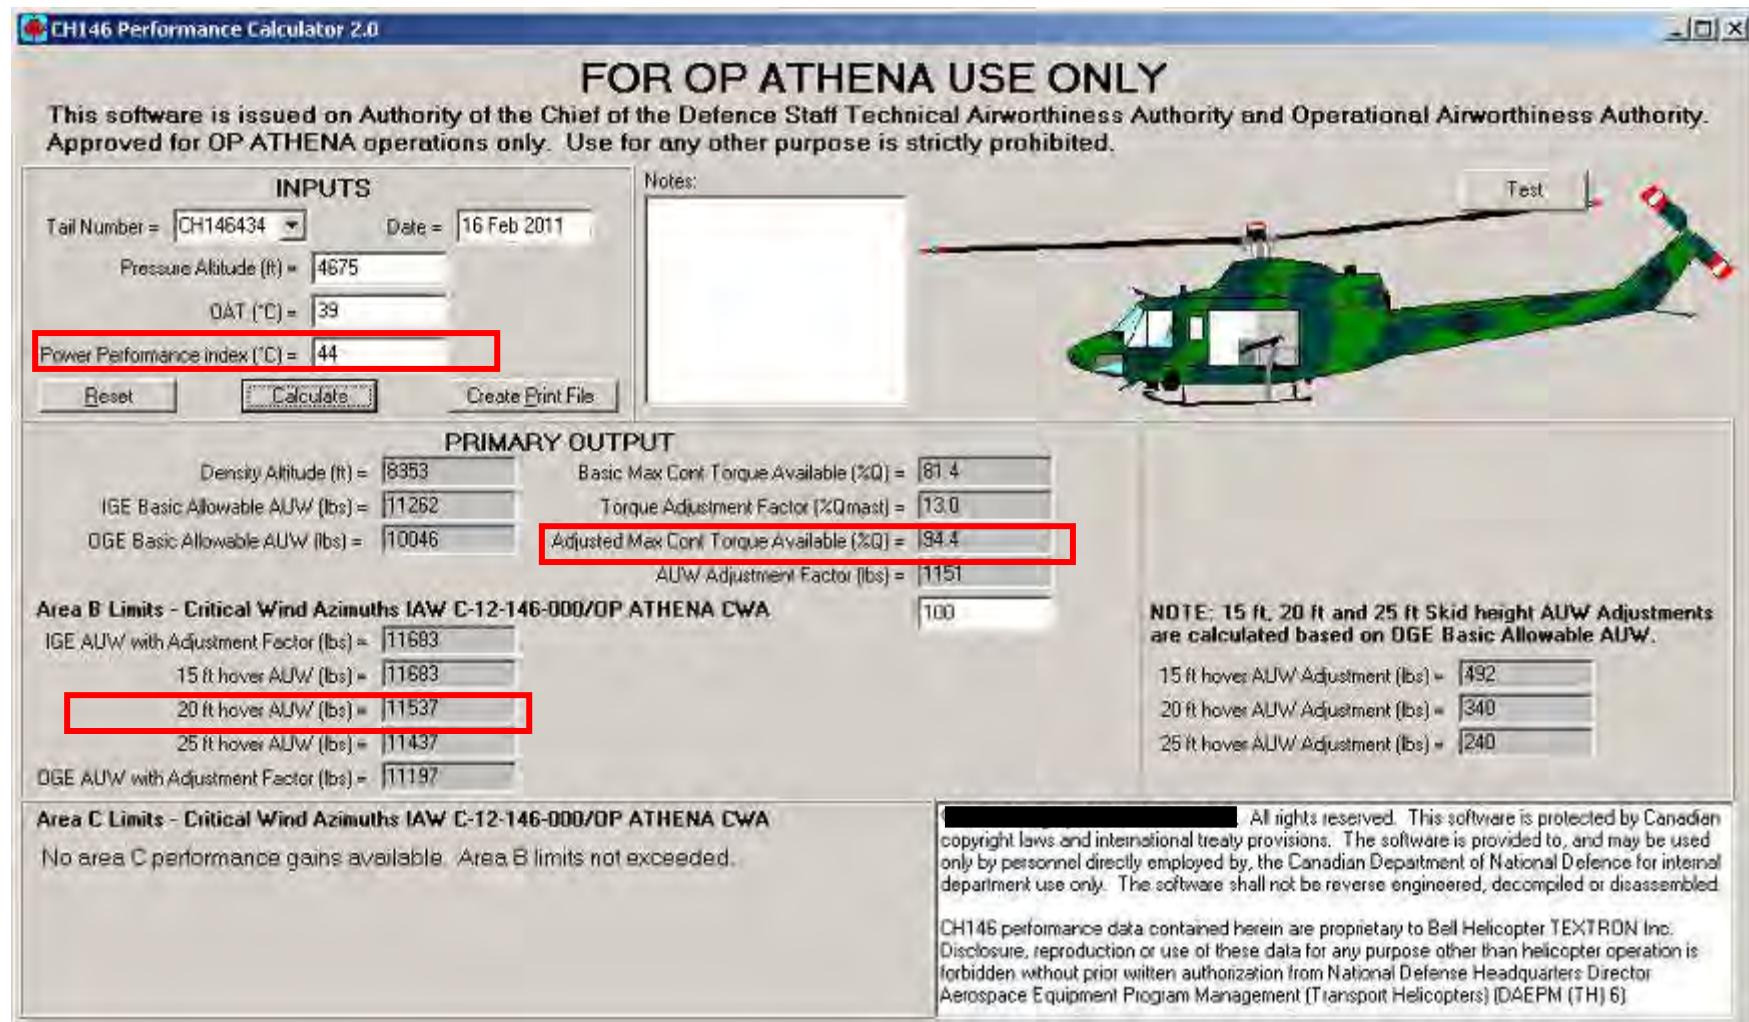
Figure 5 - The accident aircraft at a 20' hover. Note 94.4 % Qm and 44°C PPI required for an AUW of 11537lbs. 27.9°C PPI indicates that they would have seen an ITT exceedence of 16°C to hover at 20'. (44-27.9=16.1)
