Fire Protection Issues for Historic Buildings

Introduction

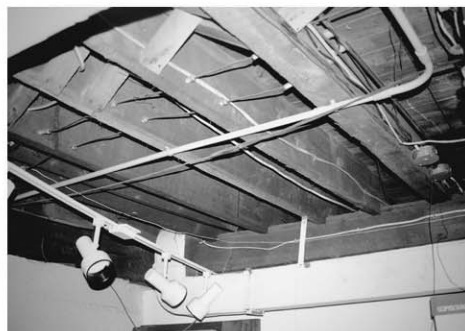
Figure 1. An example of unprotected basement ceiling joists.

ums. This is mostly the result of their high combustibility ratings and a general lack of building compartmentalization (subdivision). Wood framing used throughout the entire structure becomes very dry over the years and can ignite easily. Basement ceiling joists (Figure 1) and wall framing in attics and crawl spaces are often left unprotected. Varnished wood decor and countless numbers of combustible contents including large furniture pieces, mattresses, drapes, and area rugs, for example, provide substantial fuel. This is further compounded by the presence of open grand staircases usually rising up several floors (Figure 2). Such vertical openings provide a generous source of oxygen, and act as chimney flues that allow flames, hot gases, heat, and smoke to spread very quickly. Often fire spreads so fast that it cannot be put out by fire

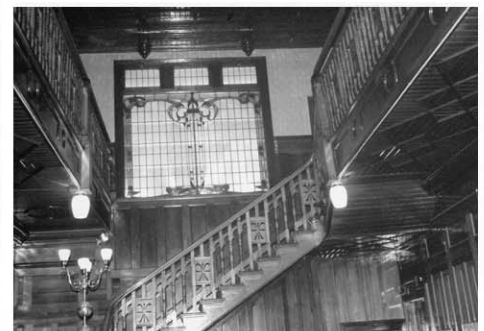
Figure 2. Open staircases allow fire and smoke to spread quickly.

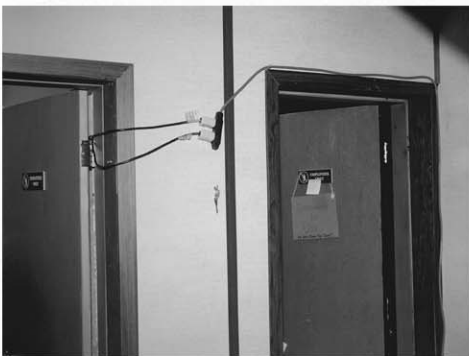
Figure 3. Temporary electrical wiring is a major fire risk; it should be replaced by permanent wiring.

Unsafe wiring is still a major fire risk. Temporary electrical wiring (Figure 3) can be easily replaced by permanent wiring. Extension cords (often running under area rugs) should be removed and permanent electrical outlets installed. Knob-and-tube wiring should be replaced by new and approved wiring. Lighting fixtures (Figure 4) should meet local electrical codes, and building wiring should be inspected every 10 years by a qualified electrician.

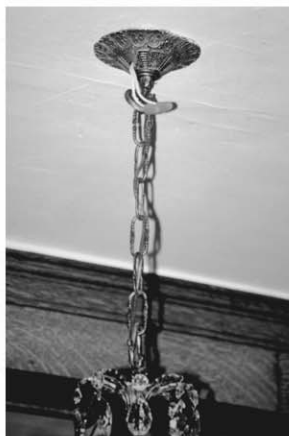
Figure 4. Exposed wiring on this lighting fixture does not meet electrical codes.

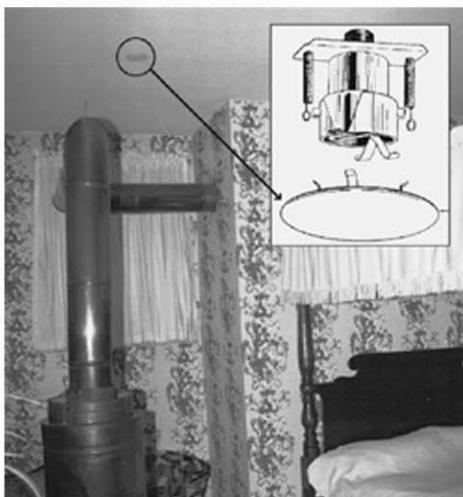
Figure 5. Sprinkler recessed in ceiling does not infringe on historic appearance.

Sprinklers do not have to infringe on the historic makeup of the building, and can be installed in subtle ways. They can be recessed in ceilings (Figure 5), or blended with architectural wood finishes (Figure 6). Recess

covers can be painted (only by the manufacturer) to match existing ceiling colour, texture, or wood grain. Experienced installers and a conscientious contractor can find innovative and imaginative solutions to mount sprinklers inconspicuously. The number of sprinklers in a room can be minimized by installing extended coverage sprinklers. Up to 37 m² (44.4 square yards) can be covered by a single sprinkler in some cases. Building damage and overall costs can be kept to a minimum by using special tools. Safe, quick, and easy pipe assembly methods can be used in place of dangerous welding and brazing methods. For example, electric resistance tools and electric pressing tools can make the assembly of copper and galvanized piping safe and easy. Thermoplastic piping is now permitted by code in wet-pipe systems with the AHJ's permission. It is easily routed in difficult and often inaccessible spaces, assembles in minutes, and is non-corrosive and shock resistant. It is also a much-needed feature in areas requiring seismic protection. Using the right type of piping for a particular installation and custom tools is another key factor in lowering damages and controlling costs.

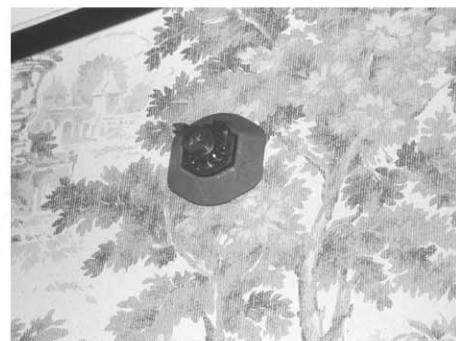
Figure 6. Sprinkler installed to blend with architectural wood finishes.
