**CANADIAN FORCES
FLIGHT SAFETY INVESTIGATION REPORT (FSIR)**

FINAL REPORT

FILE NUMBER: 1010-CH146434 (DFS 2-4)
FSOMS: 139123
DATE OF REPORT: 29 October 2012
AIRCRAFT TYPE: CH146 Griffon Helicopter
DATE/TIME: 06 0908Z July 2009
LOCATION: Forward Operating Base, Afghanistan
CATEGORY: "A" Category Accident

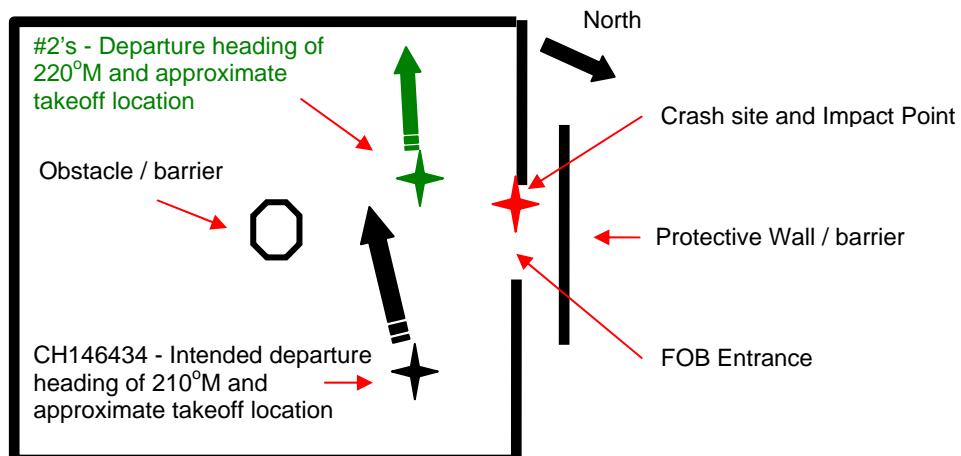
Figure 1: FOB Diagram – Not to Scale

1.4.1 Collateral damage was limited to the barrier surrounding the accident site. There is a gap in the barrier that serves as an entrance to the FOB. This gap is protected by another barrier outboard of the FOB to protect the FOB entrance. This protective wall also sustained damage.

1.4.2 The aircraft fuselage struck and damaged the barrier's metal wire mesh structure ([Annex A: Photo 2](#)). All other damage to the barrier's retaining membrane (inner fabric) was caused by either fire or contact with flying aircraft debris. There were two main rotor blade strike marks at approximately a 45° angle on the right side of the impact point on the barrier ([Annex A: Photo 3](#)).

1.10.1 There were a great number of FOBs in Afghanistan. In the conduct of their assigned missions, Canadian aircrew were required to fly to several FOBs, many of which were not, as in this case, under Canadian control. This foreign controlled FOB measured approximately 450 ft wide by 420 ft long. The FOB entrance was located approximately in the middle of the northern wall. In the middle of the FOB was an obstacle surrounded by a HESCO barrier. A helicopter landing site was marked by rocks placed in a circle on the west side of the FOB. There were no other markings for the helicopter landing site. (See Figure 1, paragraph 1.4)

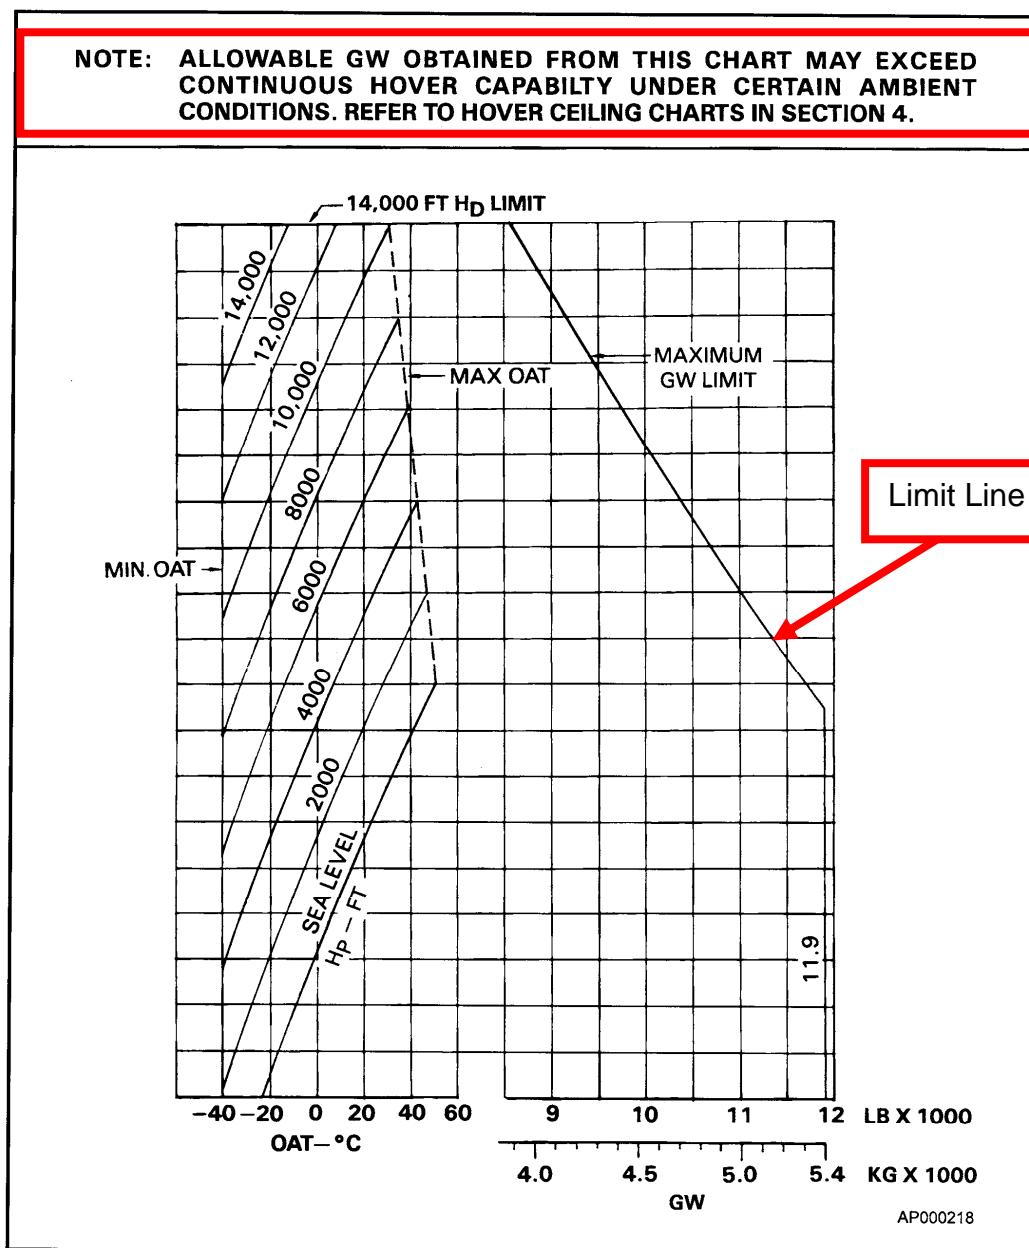
Figure 1-1: WAT Chart – IGE

1.16.2.3 It is important to note that the title change of **Figure 1-1** and the removal of **Figure 1-1A** from the AFM reversed the changes that were introduced by AFM Ch 2. Further, **Figures 8-11 to 8-13** were removed because they were viewed as incomplete, potentially misleading and of questionable validity.

Note: Notice the note referring to the Hover Ceiling charts and the Limit Line to guarantee Min Spec performance.

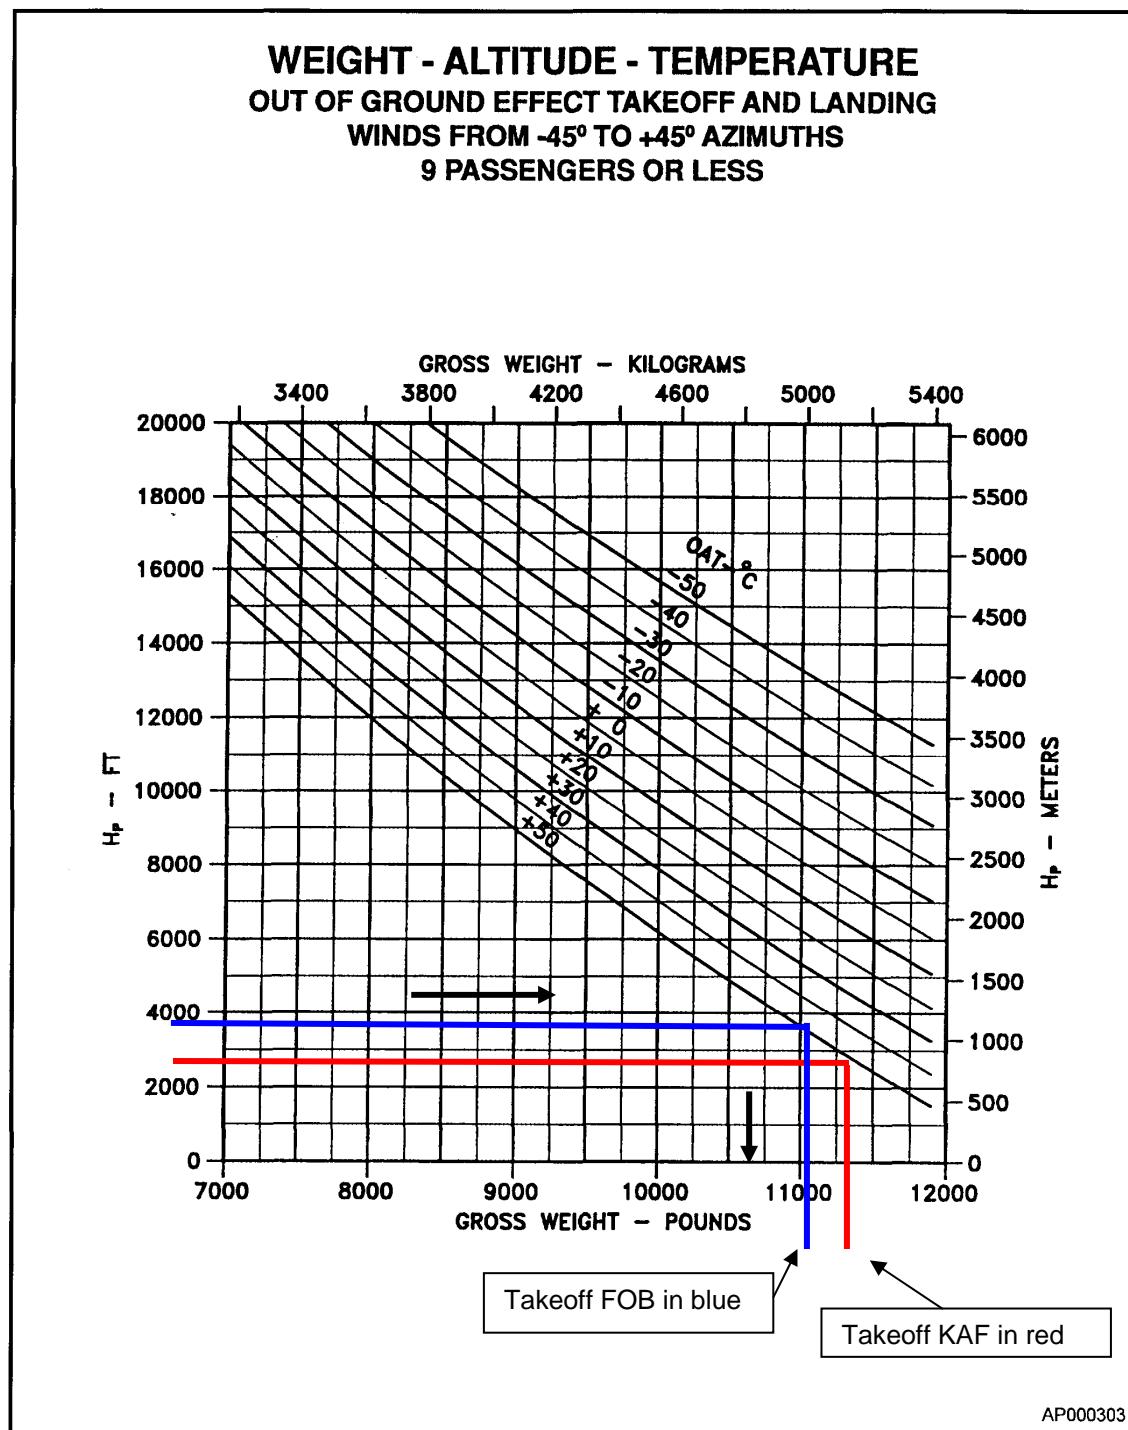
Figure 8-12: WAT Chart – OGE

3.5.1 Ref A includes some hover performance charts in Section 8, at Figs 8-11, 12, and 13. These charts are not included in the Model 412 AFM, Ref D, and were created specifically for the CH146 at DND/CF request. The technical basis for these charts is not known at this time. Unfortunately these charts do not reflect the WAT reductions due to engine temperature limits at higher air temperatures. If used by aircrew for flight planning in conditions where engine temperature limits could be encountered, the charts may suggest more performance capability than is actually available. This could contribute to a flight safety situation.

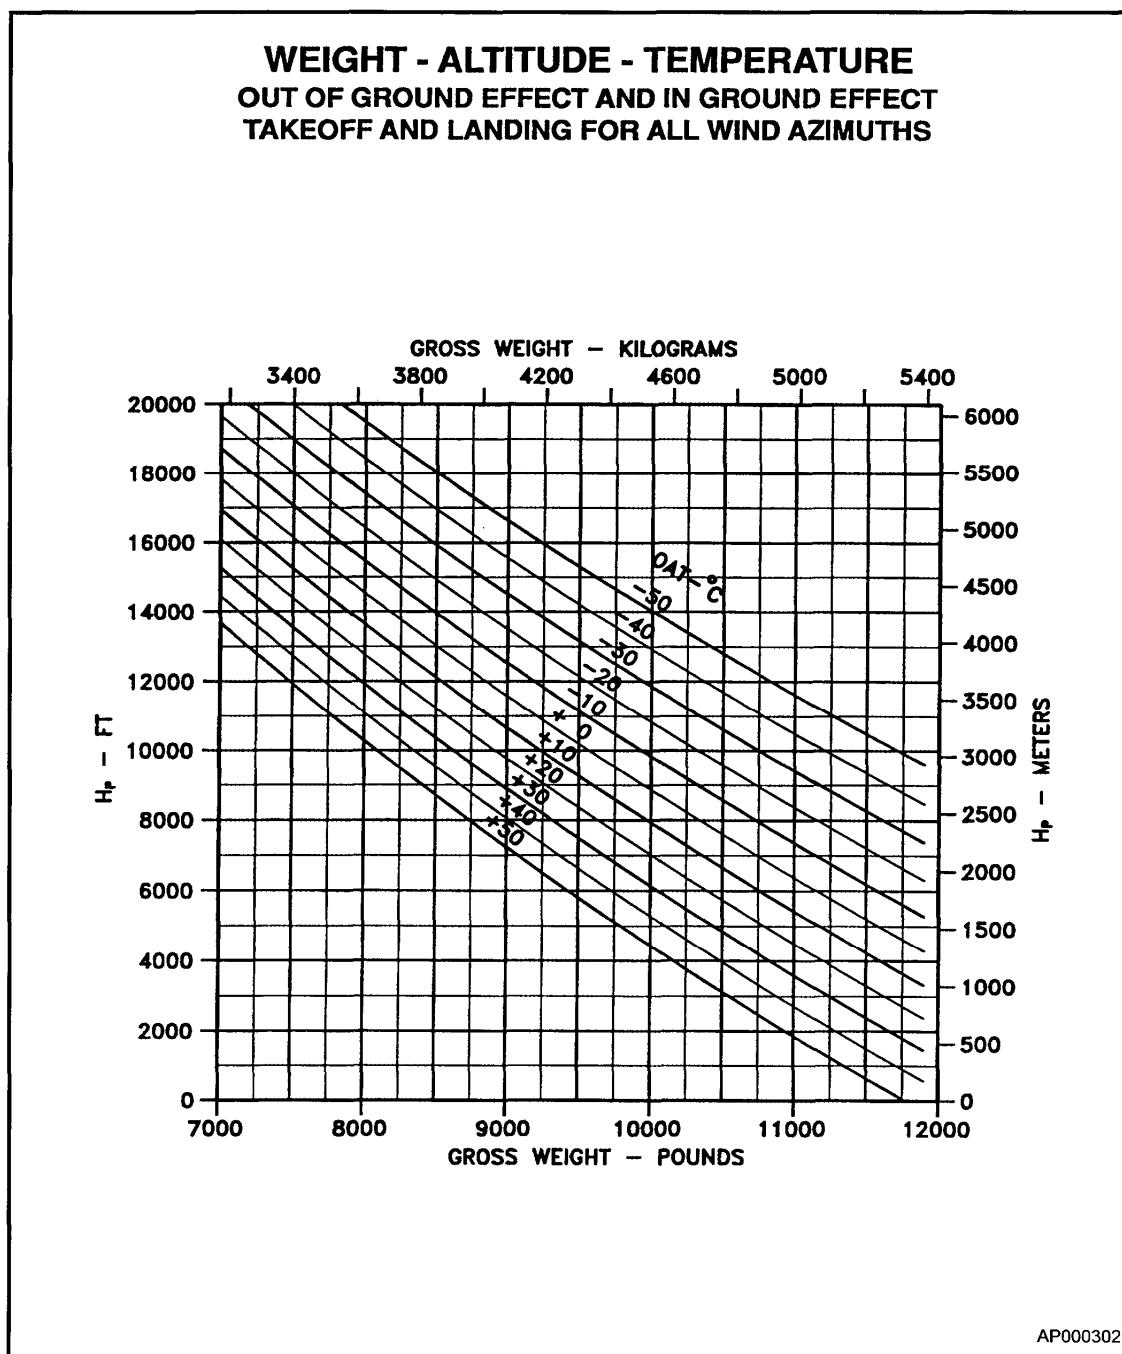
Figure 8-11: WAT Chart – OGE

2.11.1.2 A review of the various pre-deployment decision briefings conducted prior to the deployment into Afghanistan revealed that the CH146 capabilities and limitations were presented by experienced aircrew but focussed mainly on its range and payload capacities. The limited CH146 performance data that was presented was based solely on **Figure 8-11 WAT chart, all azimuths** ([Annex C pg 4/6](#)) of the AFM. As previously indicated in paragraph 1.6.5, the WAT Charts

only determine the maximum allowable weight and maximum HD for takeoff, landing and IGE/OGE hover operations. The Hover Ceiling, Cruise Performance or Hover Torque Required charts were not referenced and, therefore, critical aircraft performance information was not presented. Given the high HD operating environment, the overall expectation was that the aircraft would be power-limited and that performance would be limited by parameters such as Q_m . However, the brief presented little information concerning power performance including Q_m or ITT. With the briefed aircraft capabilities and limitations based solely on the **Figure 8-11 WAT chart**, and while CH146 power performance may not have been presented, the chain of command could have been left with the impression that the CH146 performance would be significantly better than it actually was. On one hand, despite the challenges of operating at high OATs and HDs, the Griffon was suitable and very effectively employed within operational limits for operations in Afghanistan for certain specific missions (e.g. passenger transport in winter months when OAT was lower, Intelligence Surveillance and Reconnaissance (ISR) missions, Escort, and Fire Support roles when properly managed.) On the other hand, passenger transport or other utility flights in such extreme environmental conditions, with OATs and HDs, combined with flights conducted to very austere unprepared surfaces, at high elevations or with the potential for DVE, could prove challenging and extremely difficult to accomplish. Nonetheless, the chain of command had the full expectation that the aircraft would be operated within its performance limitations.

3.1.60 The CH146 deployment decision briefings focussed mainly on the range and payload capacity; the limited CH146 performance data that was presented was based solely on the **Figure 8-11** WAT chart. (2.11.1.2)

Note: This chart was used for CH146 deployment decision briefings.

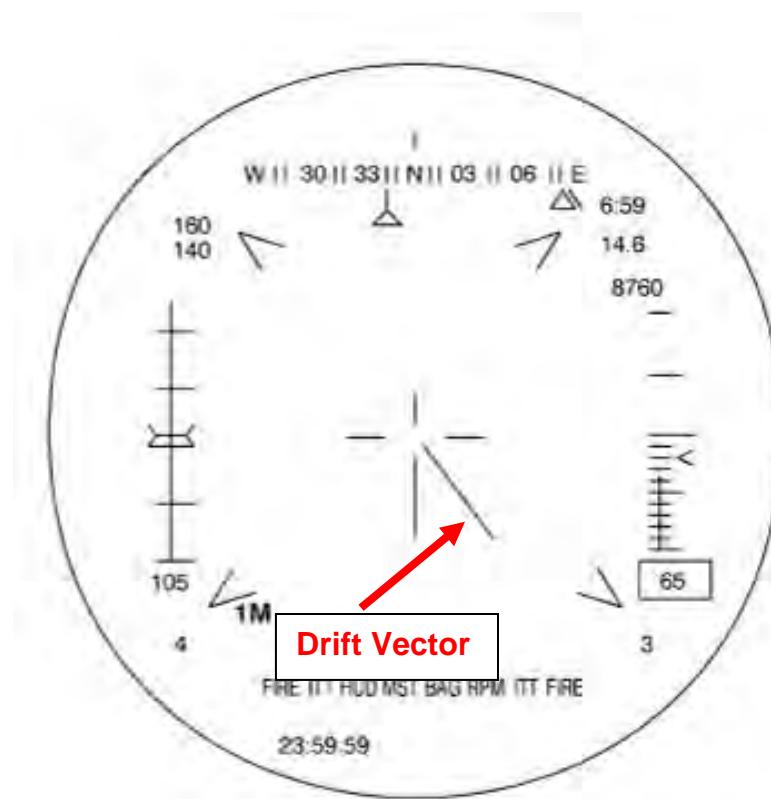
Annex I: DAY-HUD and NVG-HUD Hover Page Symbology

1. The drift vector as currently displayed would indicate aircraft movement in a direction of approximately 45° to the right and rear.
2. The hover velocity vector symbol is a single line with one end point centered on the HUD display. The symbol depicts aircraft drift magnitude and direction over a range from zero to 10 knots groundspeed and from 0°M to 359°M . As speed increases the symbol elongates. The direction of the line from the centre of the display indicates aircraft drift direction relative to aircraft heading. Above 10 knots the symbol blanks.
