Blackwater Gold Project

Fish Habitat Compensation Plan Summary

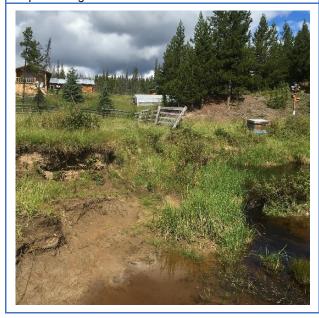
Cattle Trampled Banks and Bed

Cattle have trampled channel banks and bed while grazing and watering, which has led to a lack of a defined channel, over-widening, fine sediment input, and/or lack of riparian vegetation.

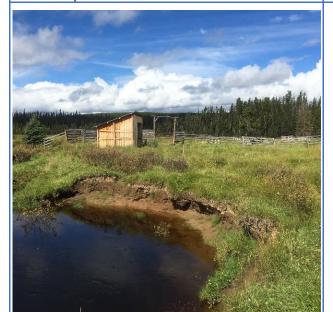
Exposed Channel Banks

Erosion and lack of bank or riparian vegetation has led to exposed and over-steepened channel banks. This has led to rapid bank erosion and slumping, and increased sediment inputs into the channel.

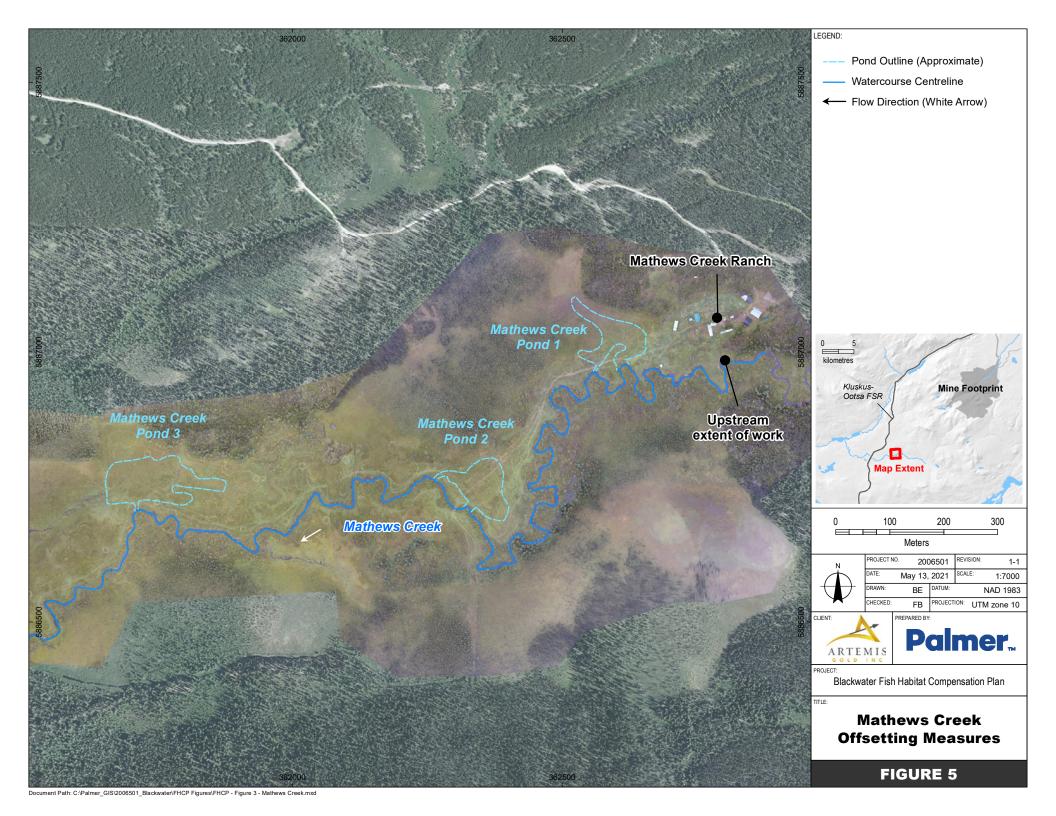
Restoration and enhancement of Mathews Creek will create high-quality feeding, migrating, and rearing habitat for rainbow trout and the other fish species that live in Mathews Creek. Construction of three new off-channel ponds will create new deep areas that will not freeze to the bottom over winter, allowing fish to survive during cold periods. The new and enhanced habitat will benefit rainbow trout and the many other species that live in the Mathews Creek watershed, including burbot, brassy minnow, slimy sculpin, longnose dace, and white sucker. Figure 5 shows the location and extent of new habitat construction,
