Characterizing and monitoring permafrost in Kugluk Territorial Park How do changing permafrost conditions impact ATV trails?

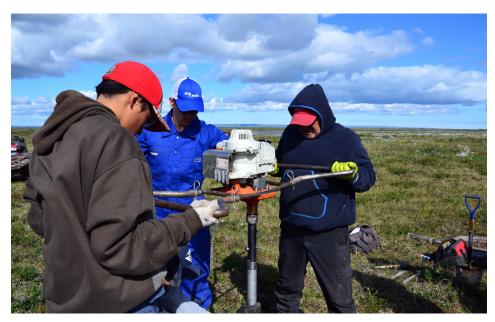
Researchers, including Kugluktuk youth and park staff, operate a portable earth auger to sample permafrost: POLAR

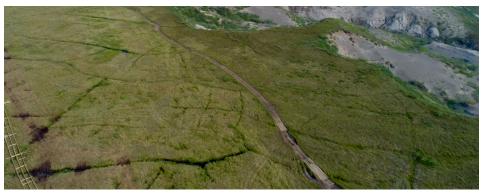
This aerial photo (above) shows the new Kugluk Territorial Park ATV trail under construction in 2019. Ice wedges, a feature of permafrost, are visible. The permafrost soil sample (upper right), collected along the ATV trail, has high ice content: POLAR

On the ground, ice wedges appear as raised ridges in the landscape. When viewed from above, ice wedges create a distinct polygon landscape pattern.
